## Existing condition of the bridge

Pavel Ryjáček

ŽEL. MOST V KM 3,706 PŘES VLTAVU TRATI PRAHA HL. N. - SMÍCHOV

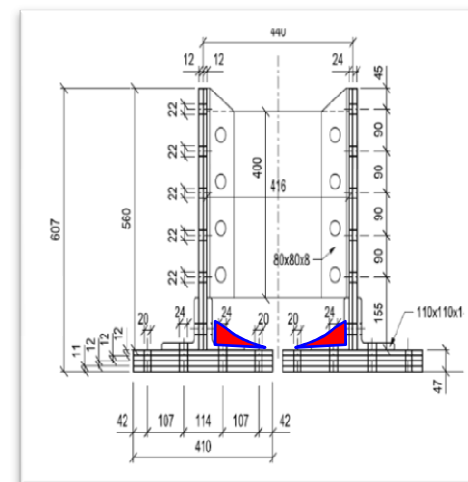
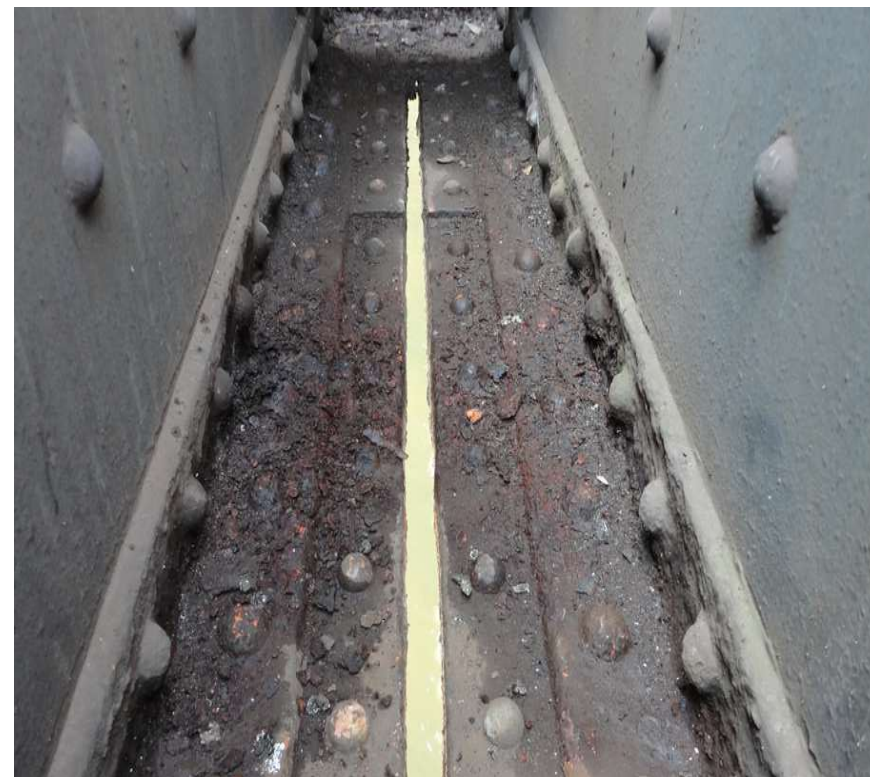
PRVEK: DOLNÍ PÁS U1-16

| SCHÉMA POLOHY POŠKOZENÍ KORÓZÍ [RELATIVNĚ K DÉLCE]: | | | | | |
|---|---|---|---|--|--|
| SP: | (1) oslabení 2 mm | (3) oslabení 2 mm | (6) oslabení 3 mm | | |
| DP: | (2) mezipřímek 80 mm oslabení 3 mm | (4) mezipřímek 60 mm oslabení 3 mm | (7) mezipřímek 80 mm oslabení 3 mm | | |

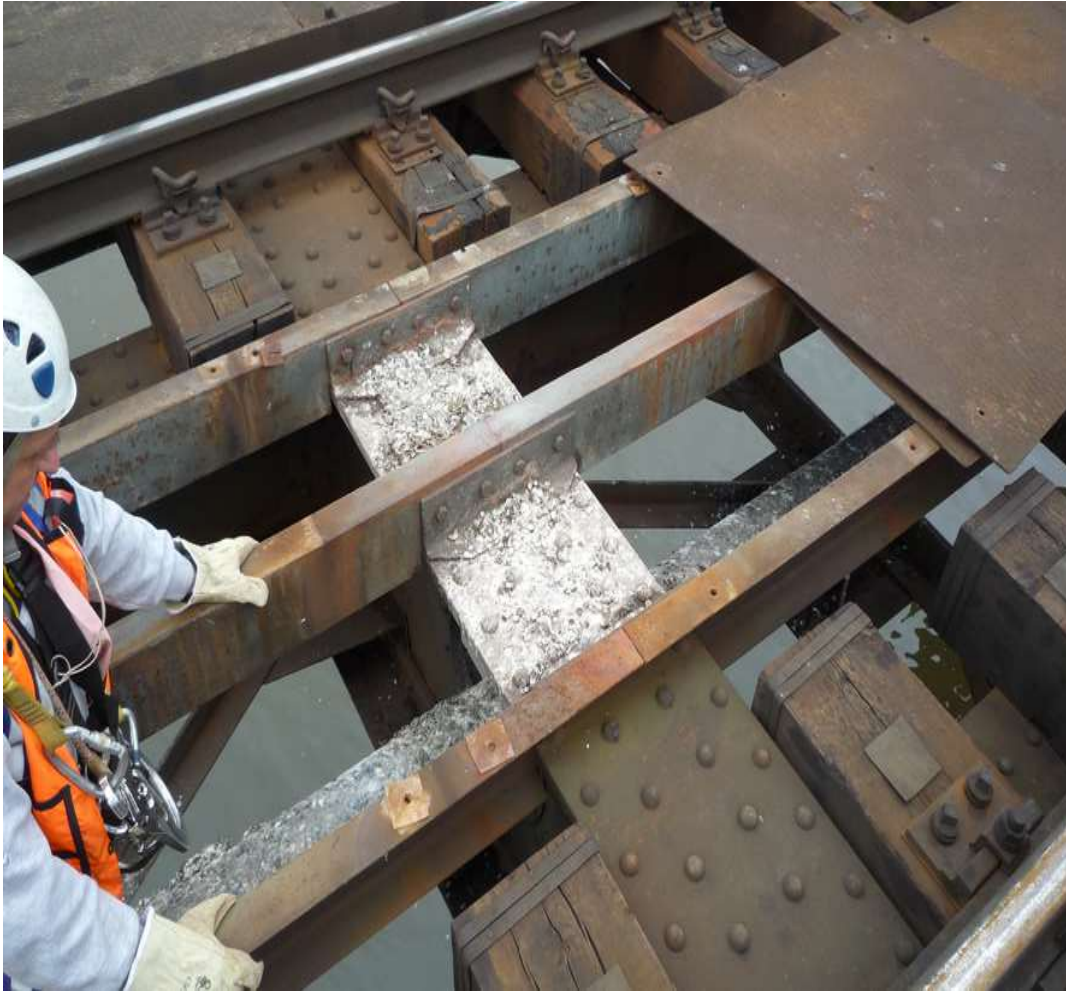
stringers - fatigue crack - length **185**

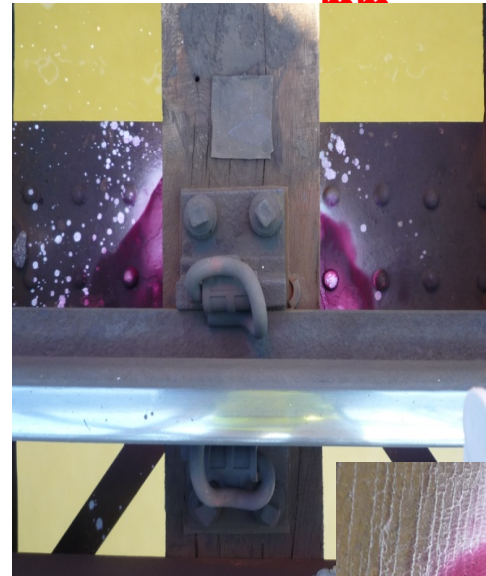
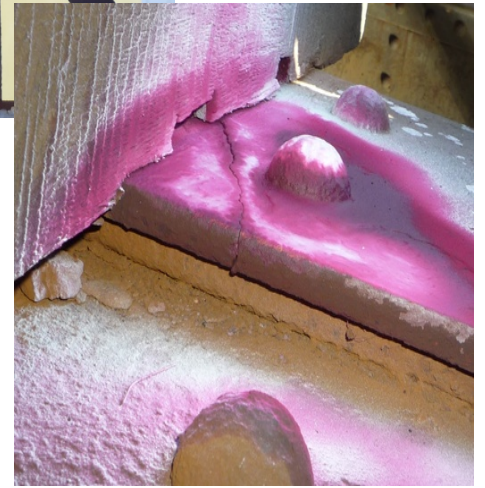
stringers - fatigue crack - length **580**  
**mm**

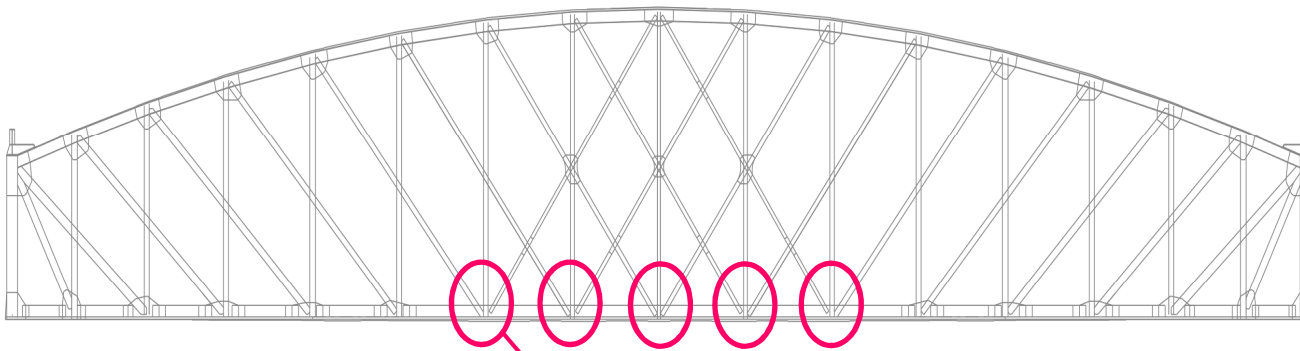
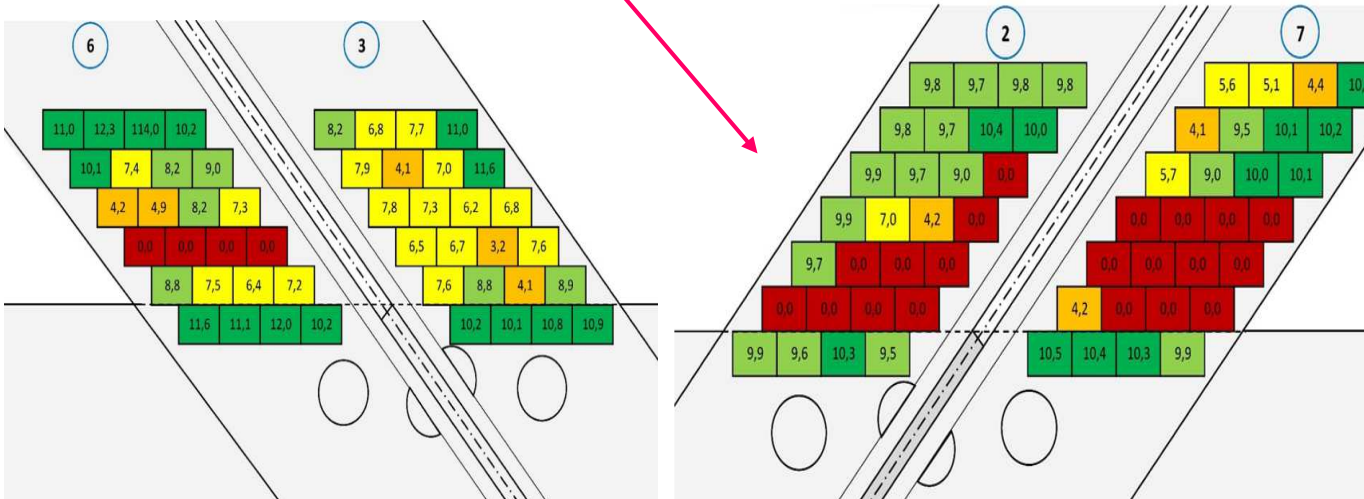
- Detailed corrosion survey (2023)
- Critical joints - diagonal x bottom chord

*Diagonals (flange thickness in mm)*

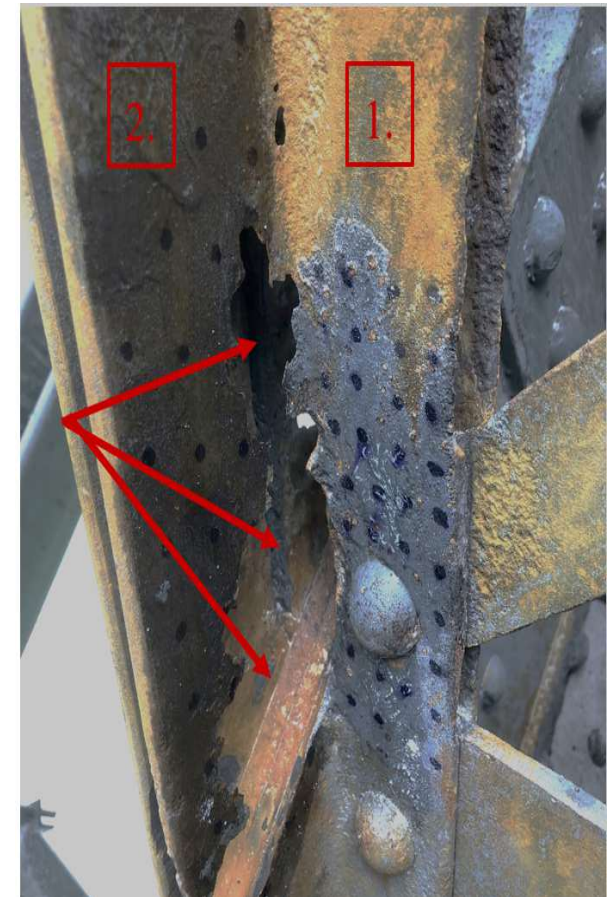
*Diagonals flanges (raster measurement)*

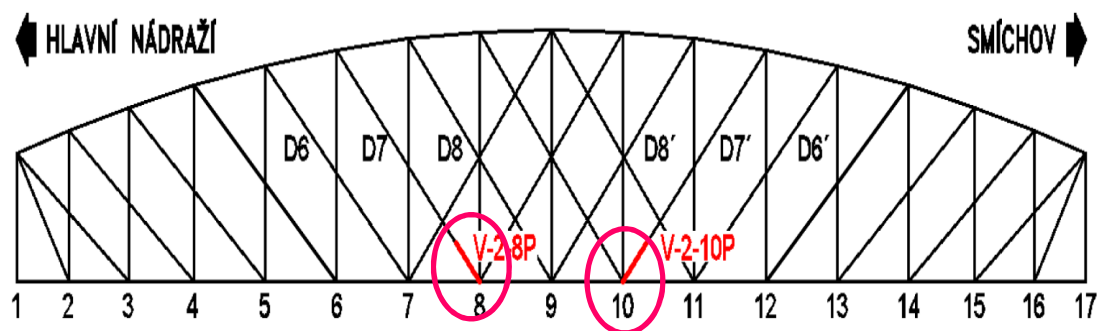
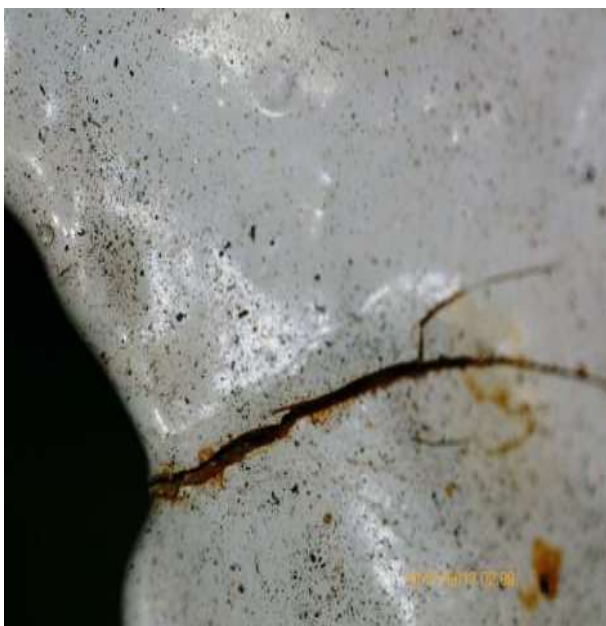
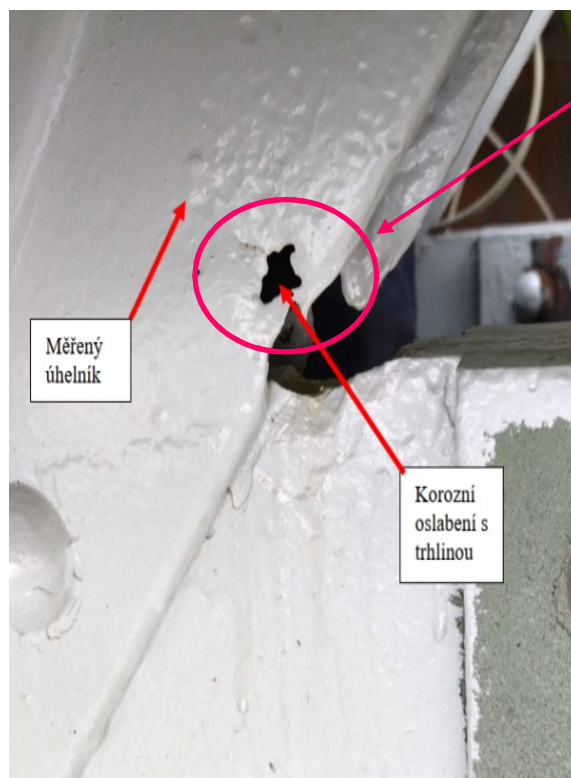
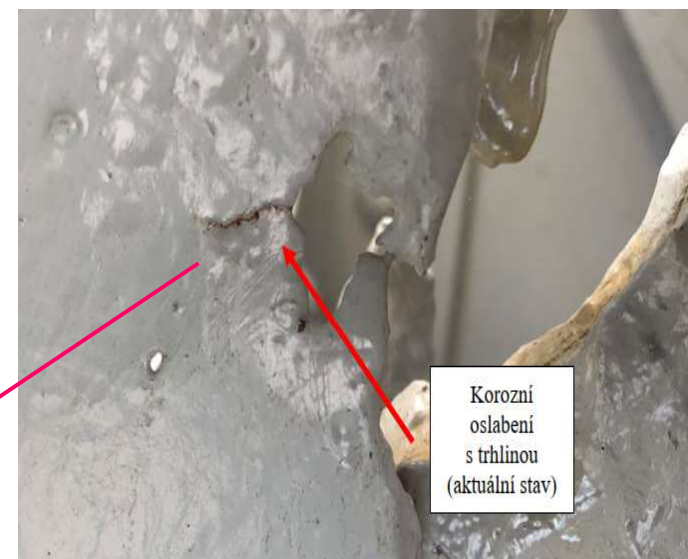
- Fatigue – stress corrosion cracks – found in several places

- CFRP strengthening – Sikawrap 301 + Sikadur 330+370
- Planned in summer 2026
- Ongoing experiments on the FCe CTU
