RENOVATION AND FUTURE

TRÁVNÍČEK

The former Beran Inn, No. 14

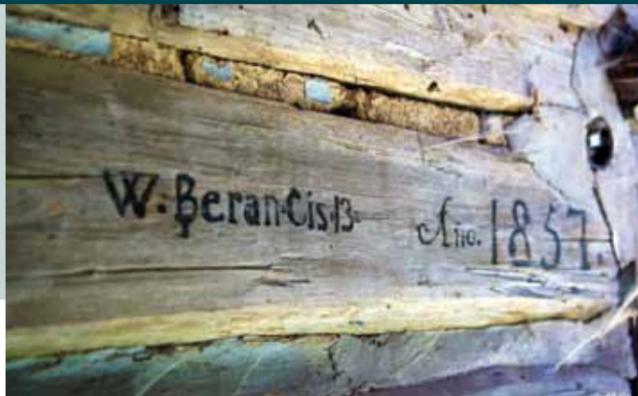
Painted date sign on the wall of the utility room floor

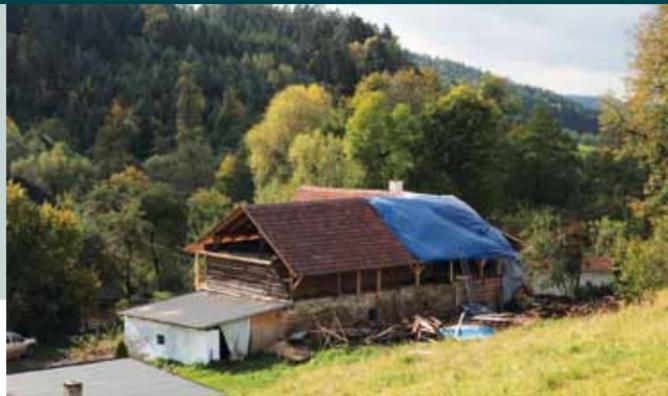
State in autumn 2017, view from the northwest

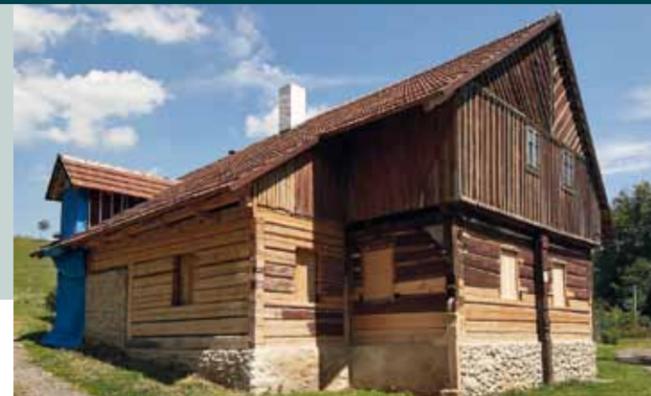
State of renovation in June 2017

The effort to save the property commenced in the fall of 2015 by removing the hazardously unstable structures in the northern corner. This was followed by a gradual replacement of the completely worn-out log joints in the outer and interior walls, construction of a new underpinning, structural reinforcement and re-alignment of ceiling joists and truss timbers for the purpose of laying new roof covering. Authentic roofing was chosen, in the form of previously used burnt interlocking tiles. A cracked vault arch in the smoke kitchen was repaired, and the brickwork of the northwest annex was partially replaced. In the following year, the worn-out log joints of the main room were replaced, and the underpinnings were

repaired. After the residential wing has been restored, works will commence to save the perpendicular farm wing.

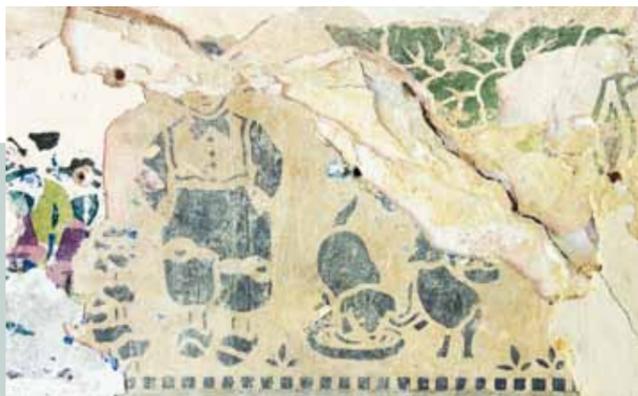
Detail of stencil painting in one of the rich interior décor layers

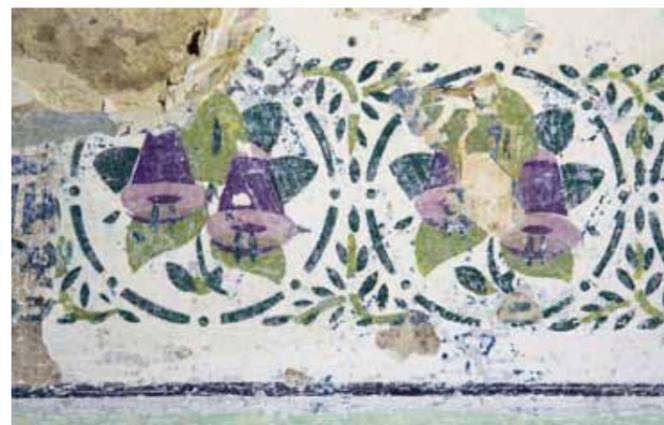
Detail of stencil painting on the interior walls

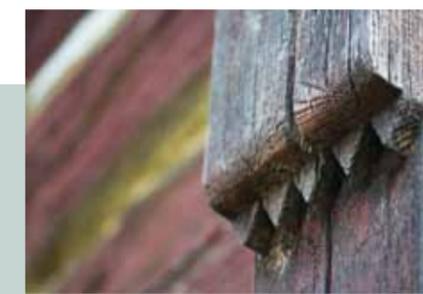
Decorative carving detail on the underpinning post

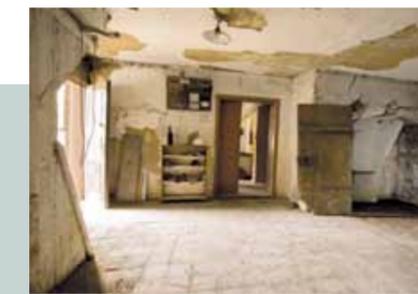
Hallway with the smoke kitchen niche

There is a smoke kitchen in the hall, modified to include a fume exhaust system.

three sections: main room, partitioned utility room section, and central walk-through hallway. The heating equipment, consisting of a stove and a bread oven, was tended from the smoke kitchen niche in the hallway. The slope of the gabled roof made it suitable for thatch covering, and the collar beam truss was partially supported by an outside structure. Still in the early 19th century, the house was expanded to include a perpendicular single-story brick annex that housed the cow barn. In 1857 (as evidenced by the date painted on the building), the side wing acquired a log upper story with utility rooms accessible from an outside mezzanine balcony. This also required modifications to the residential wing truss, and probably a new outside supporting roof structure. In the late 19th century, the inn opening required the addition of a side annex with an adjoining hallway and toilet. A second cellar was dug underneath the side annex. Around this time, a new heating system was installed: the existing kitchen niche

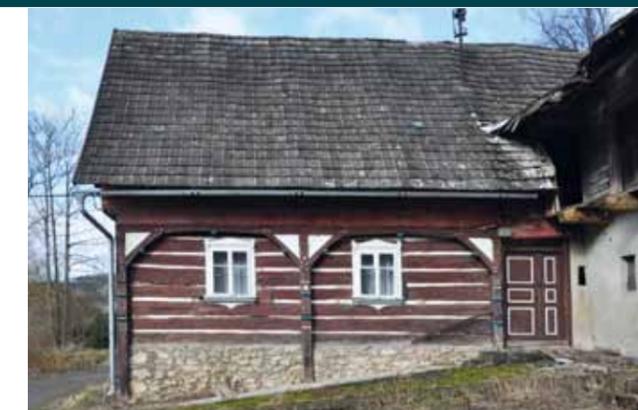
State in February 2014, view of the residential wing from the southeast

After having been neglected and in disrepair for many years, the building was purchased by its current owners in 2014. In 2015, it acquired culture heritage status and was included in the Central Register of Cultural Heritage Monuments of the Czech Republic under the number 105531. General reconstruction commenced in 2015, thanks to the initiative of the building's owner and the Dubáci society, and has managed to save the building for posterity.
